# COMPREHENSIVE FACILITIES ASSESSMENT

## COTUIT ELEMENTARY SCHOOL

140 Old Oyster Road, Cotuit, MA 02635

January 31, 2020  
H&A JN 1827.04

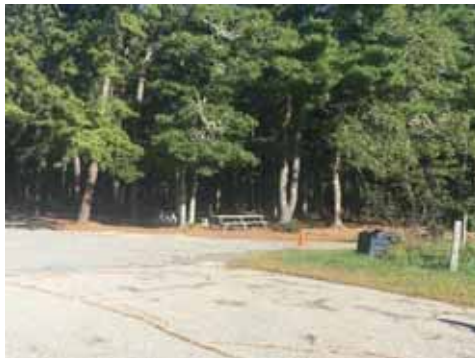
1.4: Bituminous pavement at rear of school in poor condition

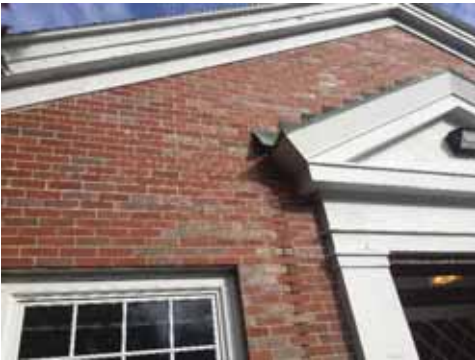
2.1: Stained and deteriorated mortar at front entrance pediment

| Work Item Description | Qty | Unit | Unit Cost | Total | <sup>1</sup> Total w/ Soft Costs | Scope 1 (Immediate) | Scope 2 (2-5 years) | Scope 3 (6-10 years) | Totals |
|---|---|---|---|---|---|---|---|---|---|
| <b>2.1</b> Clean stained brick (40 SF) and repoint deteriorated mortar (40 SF) each side of pediment roof at entry. | 1 | LS | 3,520.00 | 3,520 | 4,576 | | 4,576 | | 4,576 |

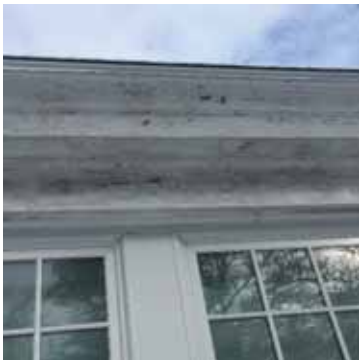
2.2: Scrape and paint soffit, rake and eave trim throughout

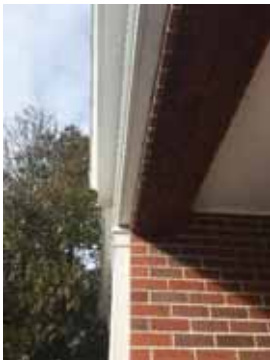
2.4: Typical rusted steel lintel to be scraped, primed and painted

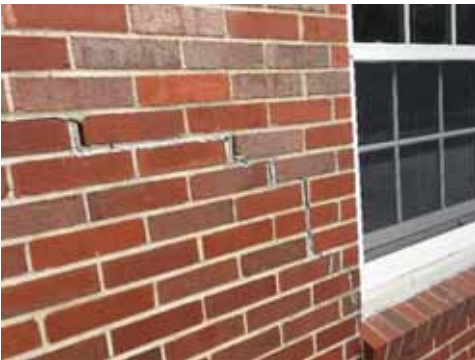
2.5: Typical cracked brick and mortar joint at corner; this condition occurs in numerous locations

| Work Item Description | Qty | Unit | Unit Cost | Total | <sup>1</sup> Total w/ Soft Costs | Scope 1 (Immediate) | Scope 2 (2-5 years) | Scope 3 (6-10 years) | Totals |
|---|---|---|---|---|---|---|---|---|---|
| <b>2.5</b> Replace 20 cracked brick and repoint 10 LF of brick masonry at cracked brick corner right of main entrance. | 1 | LS | 1,800.00 | 1,800 | 2,340 | | 2,340 | | 2,340 |

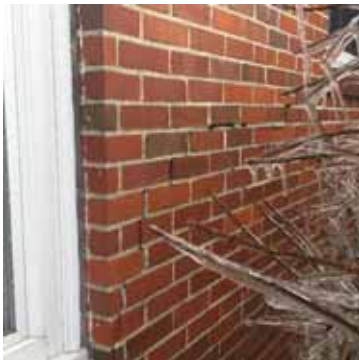
2.6: Step cracking from lower window sill to adjacent higher window sill

| Work Item Description | Qty | Unit | Unit Cost | Total | <sup>1</sup> Total w/ Soft Costs | Scope 1 (Immediate) | Scope 2 (2-5 years) | Scope 3 (6-10 years) | Totals |
|---|---|---|---|---|---|---|---|---|---|
| <b>2.6</b> Replace cracked brick (5) and repoint cracked brick mortar joints (8 LF) from sill to window corner (outside classroom 5). | 1 | LS | 600.00 | 600 | 780 | | 780 | | 780 |

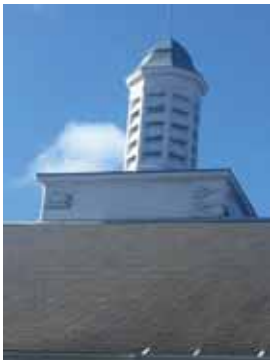
2.8: Cupola requires repainting

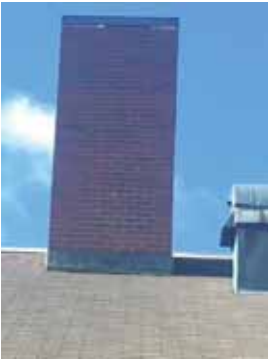
2.9: Brick chimney and cap require repair

| Work Item Description | Qty | Unit | Unit Cost | Total | <sup>1</sup> Total w/ Soft Costs | Scope 1 (Immediate) | Scope 2 (2-5 years) | Scope 3 (6-10 years) | Totals |
|---|---|---|---|---|---|---|---|---|---|
| <b>2.9</b> Repoint brick chimney (200 SF) and replace concrete cap (25 SF). | 1 | LS | 9,500.00 | 9,500 | 12,350 | | 12,350 | | 12,350 |

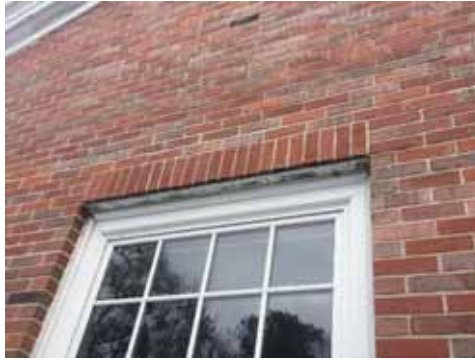
2.12: Typical condition of steel lintel at window

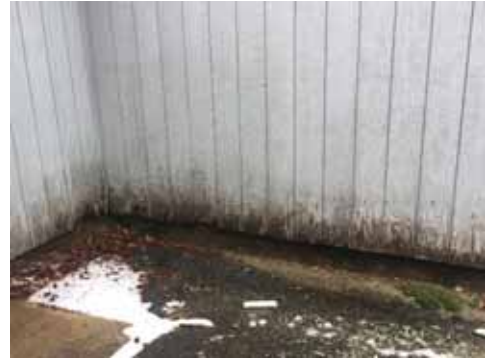
2.20: Deteriorated wood siding at modulars

| Work Item Description | Qty | Unit | Unit Cost | Total | <sup>1</sup> Total w/ Soft Costs | Scope 1 (Immediate) | Scope 2 (2-5 years) | Scope 3 (6-10 years) | Totals |
|---|---|---|---|---|---|---|---|---|---|
| <b>2.20</b> Replace deteriorated wood siding and corner trim at modulars. | 2,170 | SF | 15.00 | 32,550 | 42,315 | | 42,315 | | 42,315 |

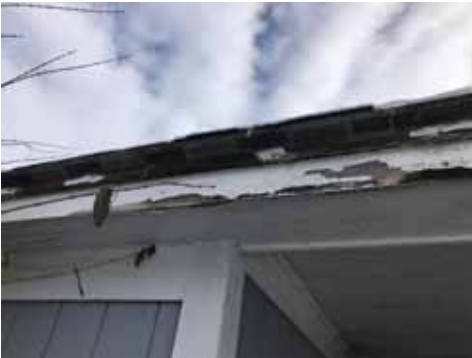
2.21: Deteriorated wood trim at modulars

| Work Item Description | Qty | Unit | Unit Cost | Total | <sup>1</sup> Total w/ Soft Costs | Scope 1 (Immediate) | Scope 2 (2-5 years) | Scope 3 (6-10 years) | Totals |
|---|---|---|---|---|---|---|---|---|---|
| <b>2.21</b> Replace deteriorated soffit, eave and rake trim at modulars. | 190 | LF | 30.00 | 5,700 | 7,410 | | 7,410 | | 7,410 |

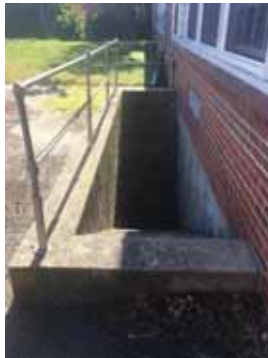
2.26: Noncompliant railings at stair to boiler room

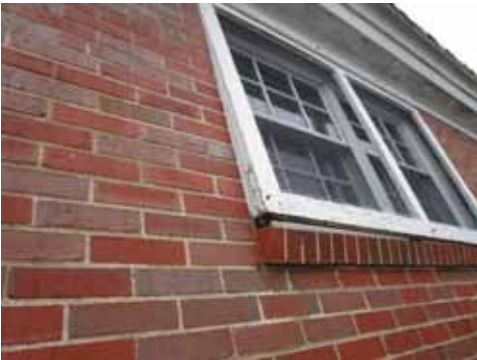
2.34: Damaged, displaced mesh wood-framed screens

| Work Item Description | Qty | Unit | Unit Cost | Total | <sup>1</sup> Total w/ Soft Costs | Scope 1 (Immediate) | Scope 2 (2-5 years) | Scope 3 (6-10 years) | Totals |
|---|---|---|---|---|---|---|---|---|---|
| <b>2.34</b> At north wall of multipurpose, in various locations, replace wire mesh window screens. | 200 | SF | 15.00 | 3,000 | 3,900 | | 3,900 | | 3,900 |

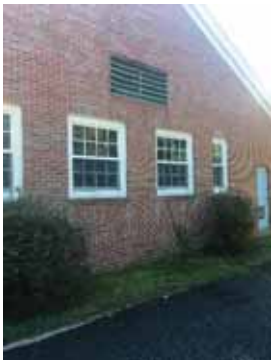
2.40: Damaged, aged kitchen louver

| Work Item Description | Qty | Unit | Unit Cost | Total | <sup>1</sup> Total w/ Soft Costs | Scope 1 (Immediate) | Scope 2 (2-5 years) | Scope 3 (6-10 years) | Totals |
|---|---|---|---|---|---|---|---|---|---|
| <b>2.40</b> At west wall of kitchen, replace louver. | 20 | SF | 80.00 | 1,600 | 2,080 | | 2,080 | | 2,080 |

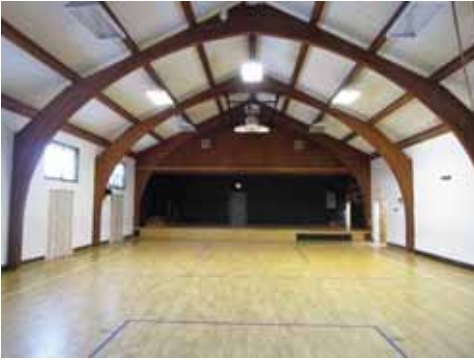
3.1: No HP access to stage; door and stair at right rear of stage

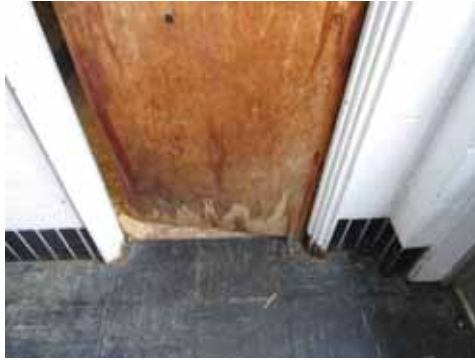
3.2: Deteriorated toilet room door to toilet

| Work Item Description | Qty | Unit | Unit Cost | Total | <sup>1</sup> Total w/ Soft Costs | Scope 1 (Immediate) | Scope 2 (2-5 years) | Scope 3 (6-10 years) | Totals |
|---|---|---|---|---|---|---|---|---|---|
| <b>3.2</b> Toilet room near kitchen - replace deteriorated interior door. | 1 | EA | 2,100.00 | 2,100 | 2,730 | 2,730 | | | 2,730 |

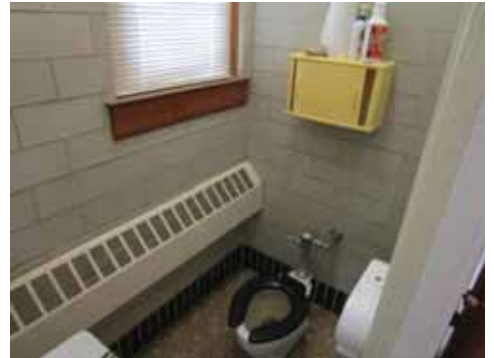
3.10: Noncompliant toilet rooms throughout the building

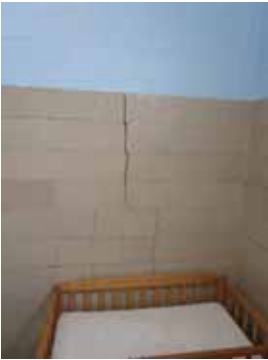
3.11: CMU crack in toilet room B

| Work Item Description | Qty | Unit | Unit Cost | Total | <sup>1</sup> Total w/ Soft Costs | Scope 1 (Immediate) | Scope 2 (2-5 years) | Scope 3 (6-10 years) | Totals |
|---|---|---|---|---|---|---|---|---|---|
| <b>3.11</b> Repair cracking in CMU wall at toilet room B. | 20 | LF | 20.00 | 400 | 520 | | 520 | | 520 |

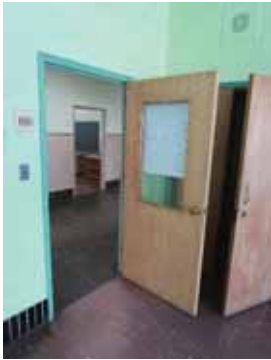
3.13: Noncompliant door hardware

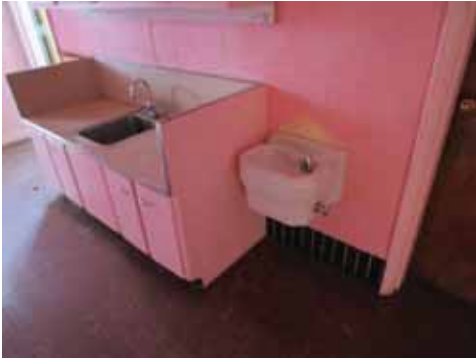
3.17: Typical classroom sink and casework

| Work Item Description | Qty | Unit | Unit Cost | Total | <sup>1</sup> Total w/ Soft Costs | Scope 1 (Immediate) | Scope 2 (2-5 years) | Scope 3 (6-10 years) | Totals |
|---|---|---|---|---|---|---|---|---|---|
| <b>3.17</b> Replace aged casework and sinks in classrooms. (1 sink and 6 LF casework x 8 classrooms) | 8 | EA | 5,500.00 | 44,000 | 57,200 | | 57,200 | | 57,200 |

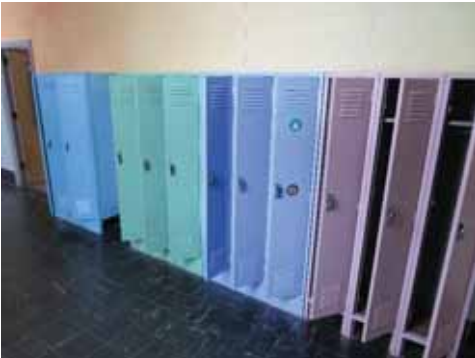
3.26: Metal lockers in poor condition

| Work Item Description | Qty | Unit | Unit Cost | Total | <sup>1</sup> Total w/ Soft Costs | Scope 1 (Immediate) | Scope 2 (2-5 years) | Scope 3 (6-10 years) | Totals |
|---|---|---|---|---|---|---|---|---|---|
| <b>3.26</b> Replace metal lockers in corridor. | 40 | EA | 350.00 | 14,000 | 18,200 | | 18,200 | | 18,200 |

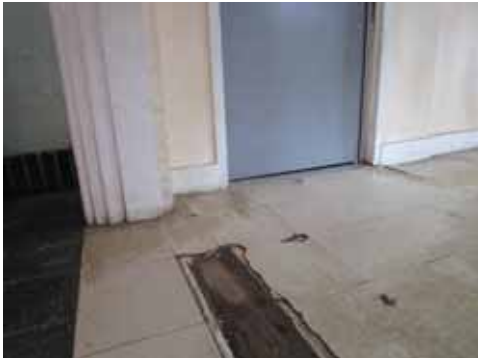
3.30: Uneven, damaged threshold between corridor and modular wing

| Work Item Description | Qty | Unit | Unit Cost | Total | <sup>1</sup> Total w/ Soft Costs | Scope 1 (Immediate) | Scope 2 (2-5 years) | Scope 3 (6-10 years) | Totals |
|---|---|---|---|---|---|---|---|---|---|
| <b>3.30</b> Replace threshold at framed door opening to modulars (trip hazard) at floor transition. | 8 | LF | 50.00 | 400 | 520 | 520 | | | 520 |

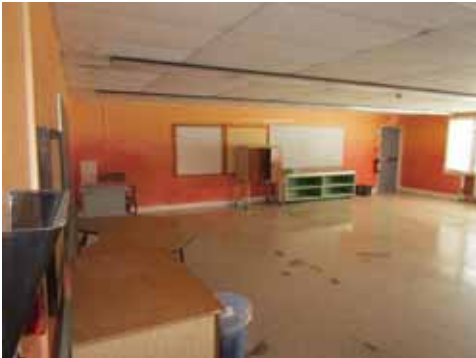
3.32: Delaminated flooring on slab at modulars

| Work Item Description | Qty | Unit | Unit Cost | Total | <sup>1</sup> Total w/ Soft Costs | Scope 1 (Immediate) | Scope 2 (2-5 years) | Scope 3 (6-10 years) | Totals |
|---|---|---|---|---|---|---|---|---|---|
| <b>3.32</b> Replace damaged flooring in modular concrete slab. | 1,825 | SF | 10.00 | 18,250 | 23,725 | 23,725 | | | 23,725 |

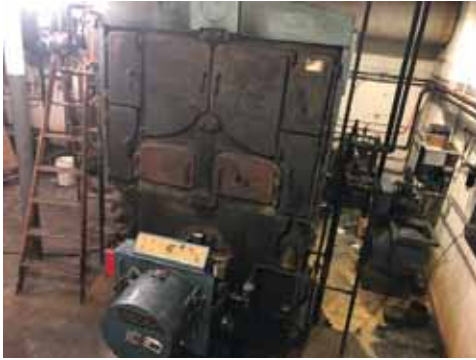
4.1: Existing steam boiler

| Work Item Description | Qty | Unit | Unit Cost | Total | <sup>1</sup> Total w/ Soft Costs | Scope 1 (Immediate) | Scope 2 (2-5 years) | Scope 3 (6-10 years) | Totals |
|---|---|---|---|---|---|---|---|---|---|
| <b>4.2 Boiler Plant: Provide New Hot Water Heating Boiler Plant:</b> Replace existing steam boiler plant with new hot water boiler plant including boilers (min 2), pumps, accessories and appurtanences. | 1 | LS | 125,000 | 125,000 | 162,500 | 162,500 | | | 162,500 |

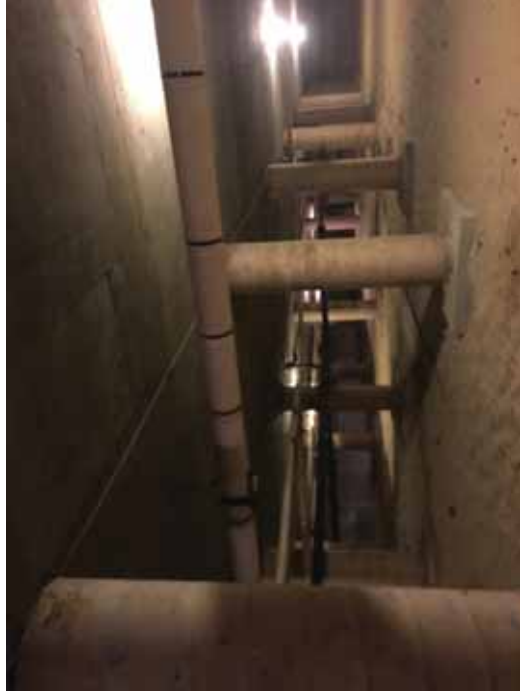
Figure 2: ACM pipe insulation/fittings in basement crawlspace

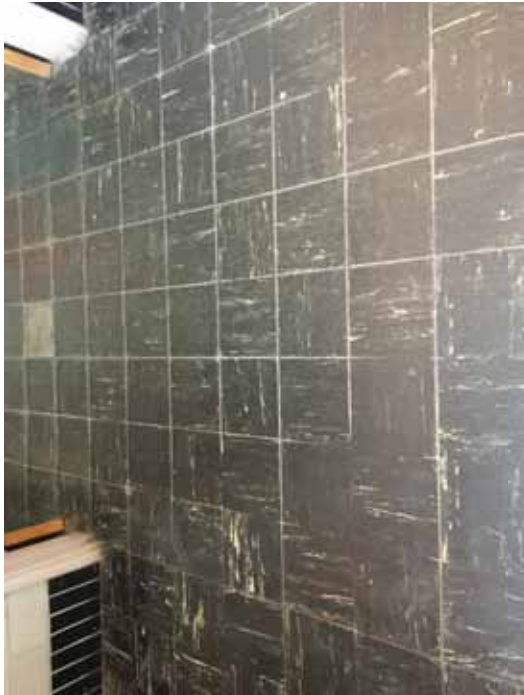
Figure 13: ACM 9" x 9" Black streak floor tile (mastic is non-asbestos)

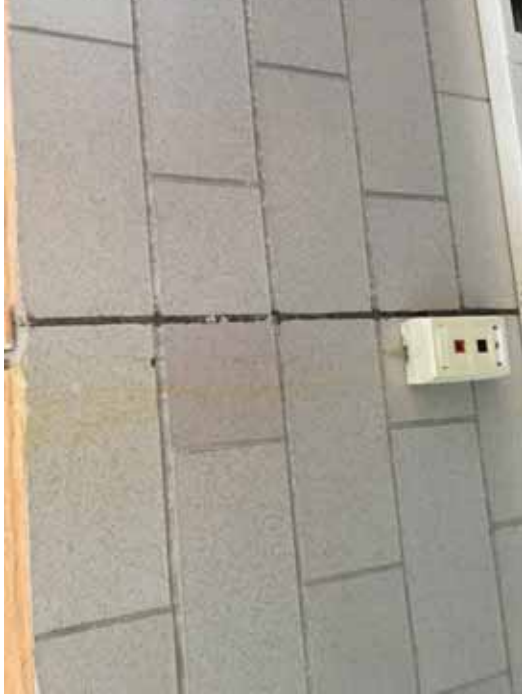
Figure 15: ACM Interior seam caulk

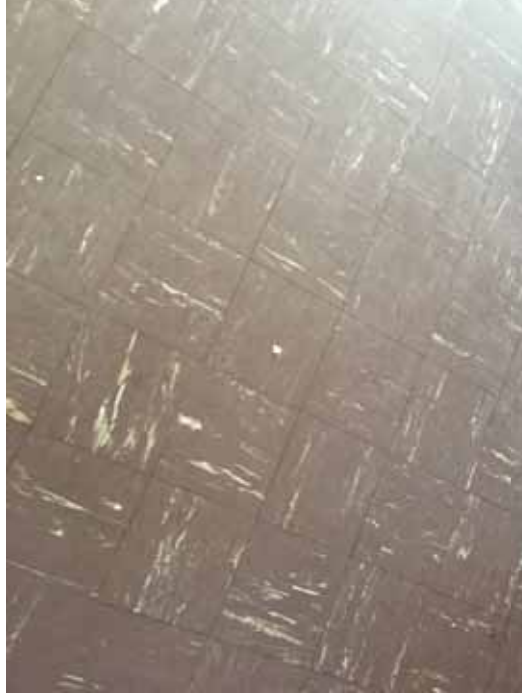
Figure 16: ACM 9" x 9" purple streaked floor tile (Mastic is not asbestos)

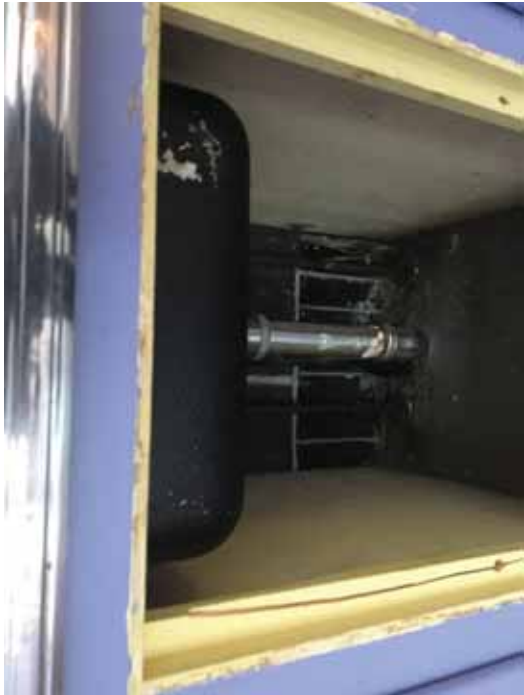
Figure 17: ACM black sink undercoat
