Feasibility Study
Cotuit Elementary School

140 Oyster Road
Cotuit, MA

May 5, 2025

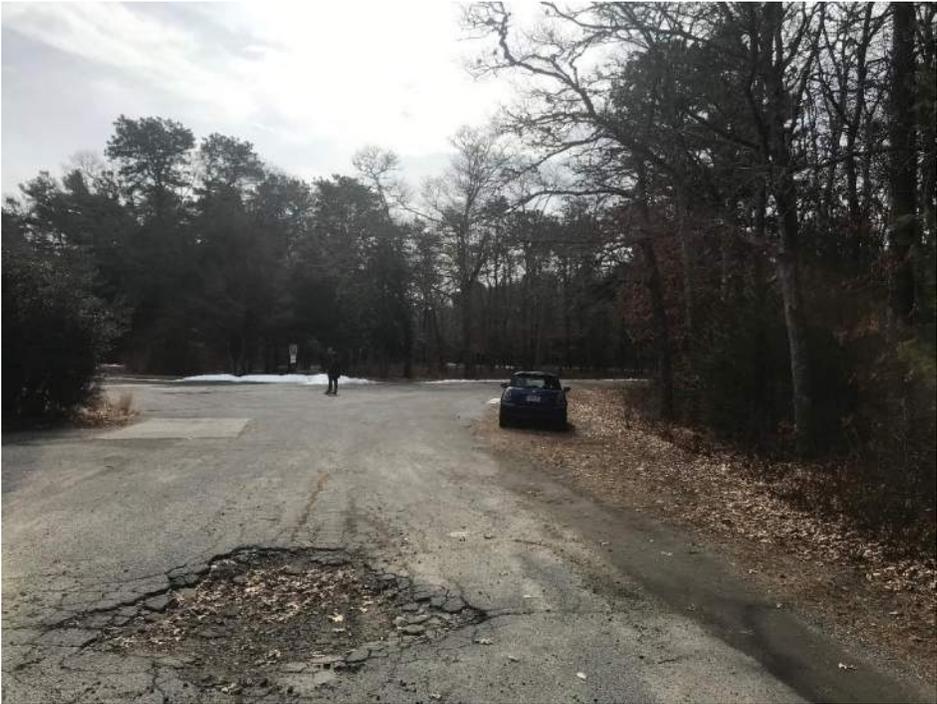
Figure 1: Existing paved surfaces in poor condition.

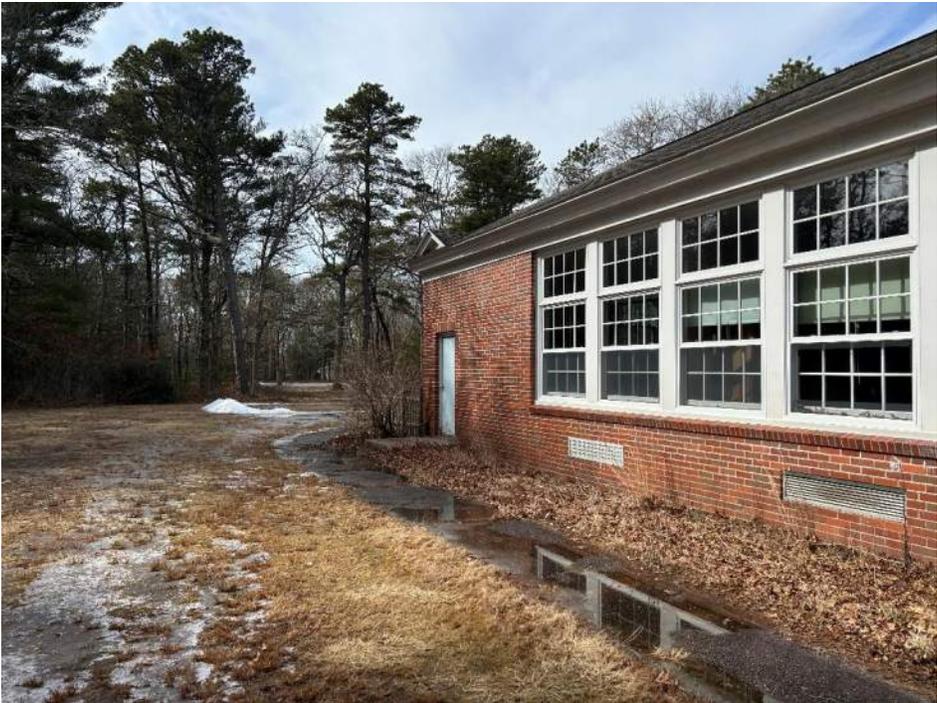
Figure 2: Areas of standing water at east side of building.

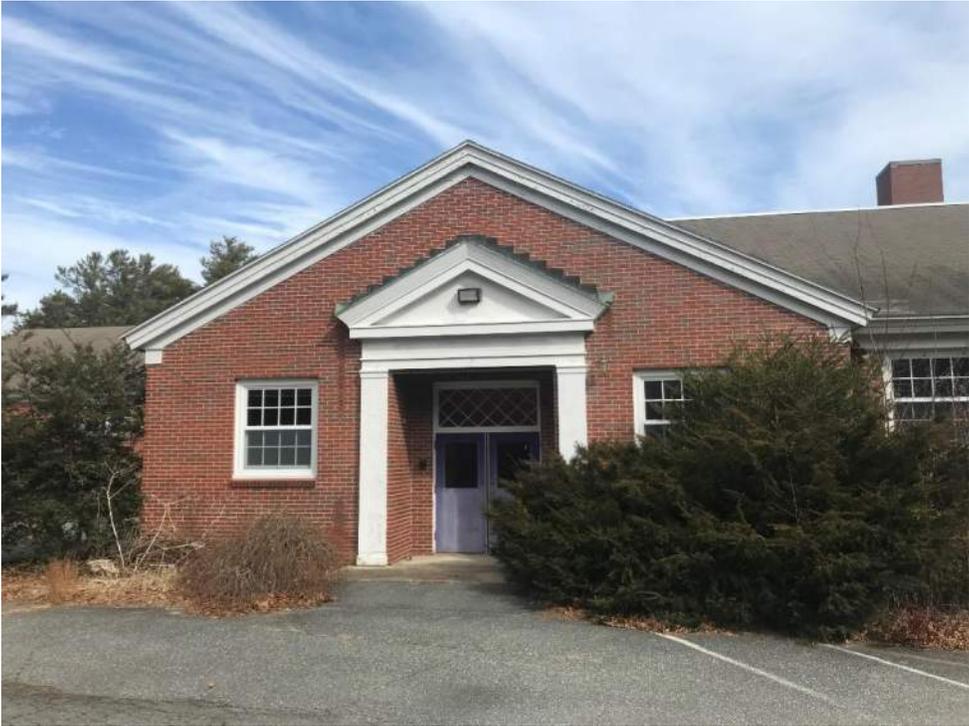
Figure 3: Typical brick masonry in good condition.

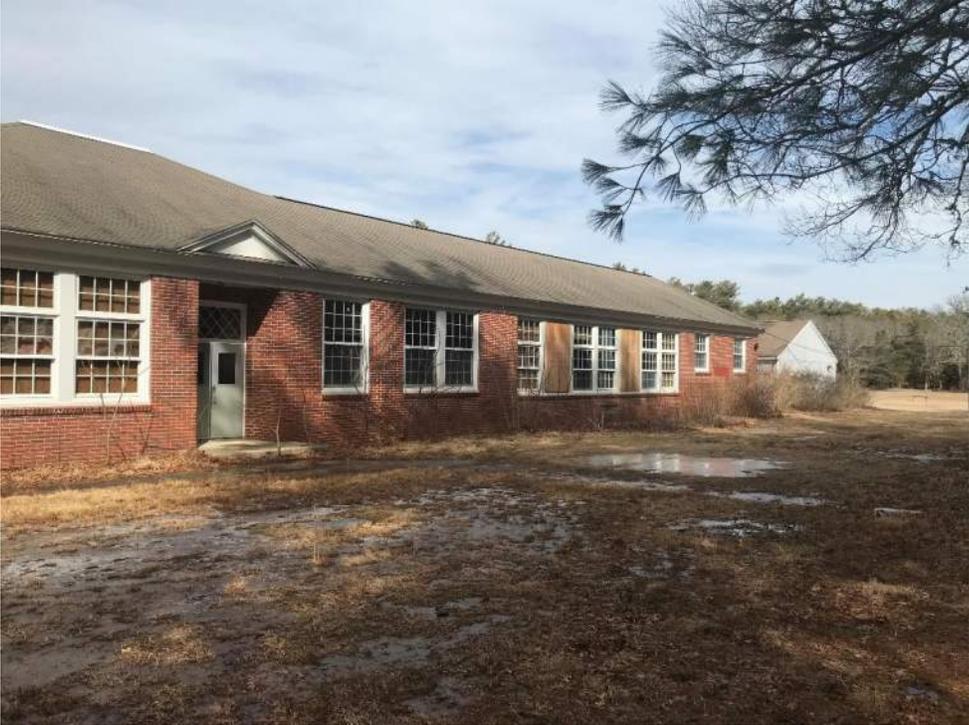
The windows are an aluminum-clad wood system with insulated glazing. There are numerous locations where glazing and screens are missing, others are boarded up entirely. The caulking around the window opening is aged and dried-out likely causing water and air infiltration. It's likely that this window system does not meet the standards of the latest energy codes. The egress and utility doors are flush metal with a metal frame. Many are rusted, damaged and have worn finishes. A few others have been recently replaced and are in good condition.

Figure 4: Worn asphalt shingles, damaged windows.

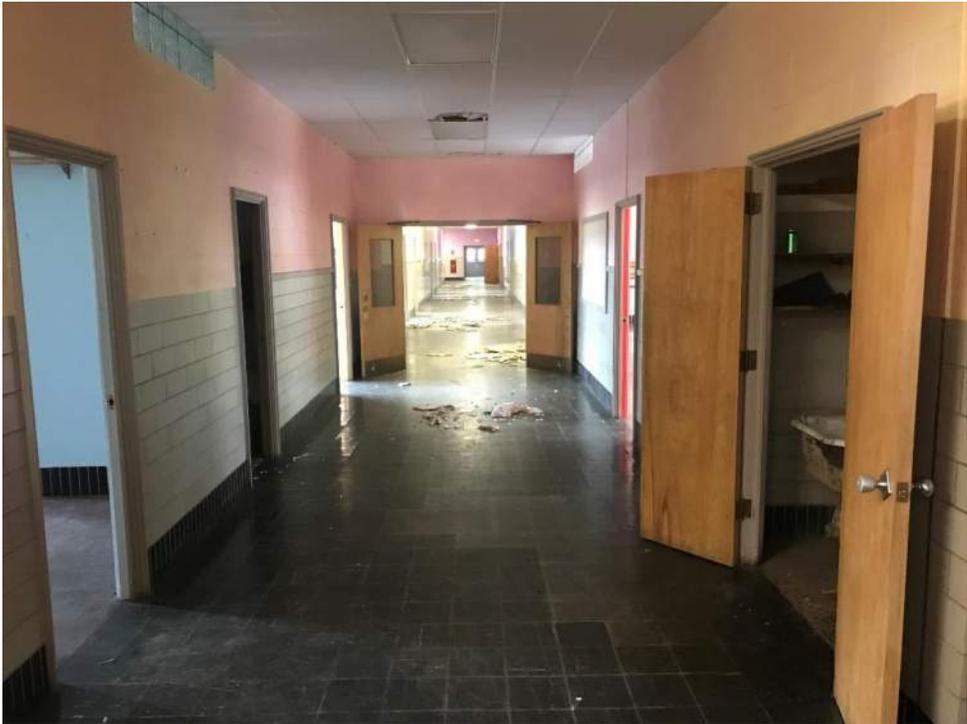
The interior finishes throughout the building are in poor condition. The vinyl tile flooring in the corridors and classrooms is badly worn, damaged and well past its useful life. The same can be said for the suspended acoustical ceiling tile systems which are badly stained and deteriorated from water infiltration. The restroom areas are undersized and do not meet the standards of present accessibility codes.

Figure 5: Worn and damaged flooring and ceilings corridor.

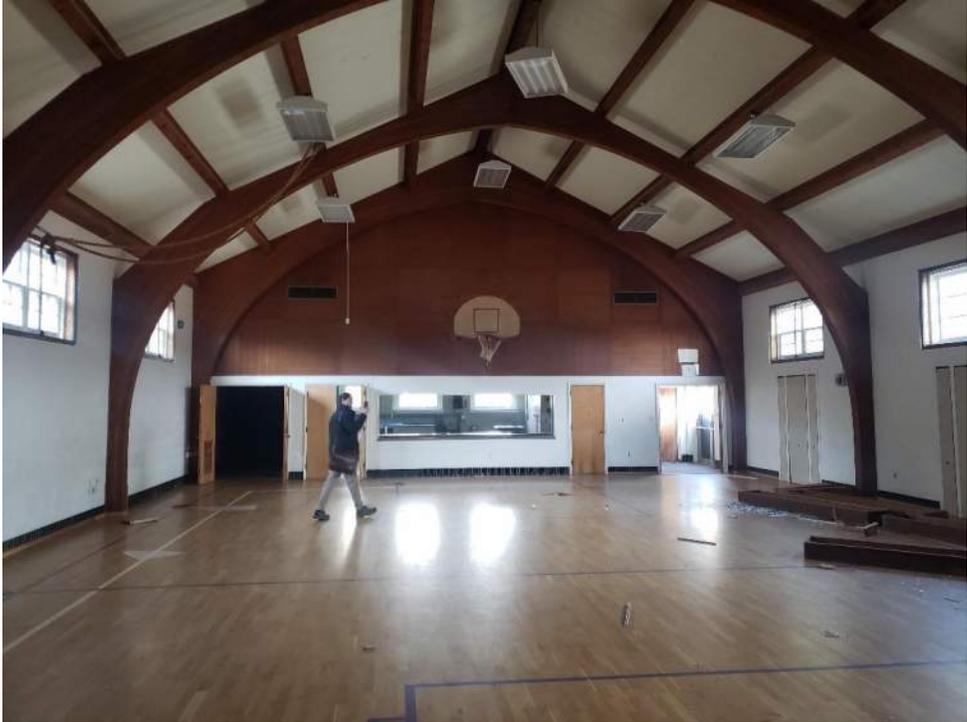
The existing gymnasium is in relatively good condition. The wood flooring is still intact, worn in some spots but not damaged. It should be noted that the gymnasium was designed for elementary school use and does not meet the size requirements for high school, college or adult-league basketball.

Figure 6: Existing Gymnasium

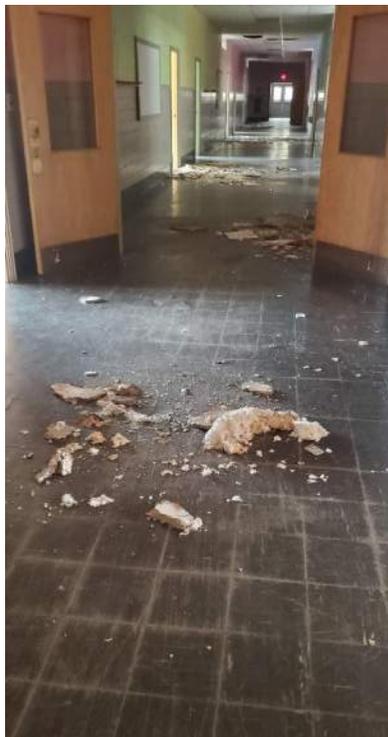
Figure 7: Floor tiles containing asbestos.

Prior to any type of building renovation or demolition, a thorough investigation is required to identify and quantify ACM which may be impacted by those types of activities. The survey is required by the United States Environmental Protection Agency (EPA) National Emissions Standard for Hazardous Air Pollutants (NESHAP) regulations (Title 40 CFR, Part 61, Subpart M); MassDEP regulations (310 CMR 7.15); Massachusetts Department of Labor Standards (MADLS) regulations, (454 CMR 28.00); as well as applicable portions of the Occupational Safety and Health Administration (OSHA) asbestos in construction regulations (CFR 1926.1101). It is understood that an assessment was performed in 2019; however, regardless of the option chosen, a supplemental pre-demolition assessment must be performed. See attachment 3 for the design narrative completed by Tighe & Bond which explains abatement requirements and costs.

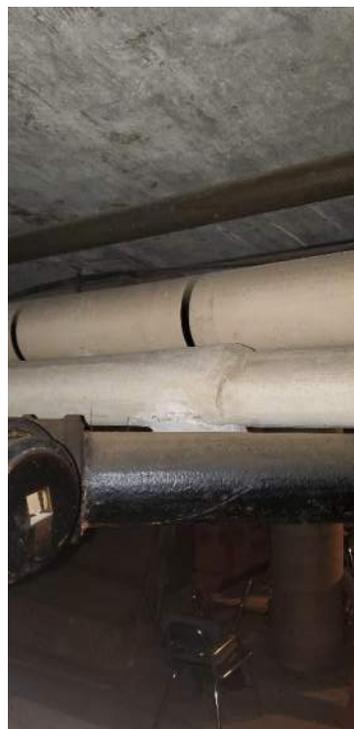
Figure 8: Pipe insulation containing asbestos.

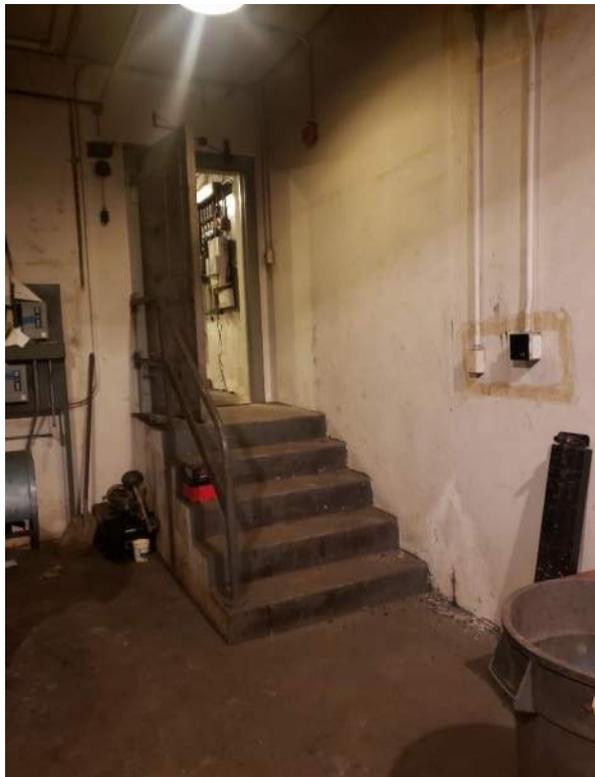
The existing foundations consist of Cast-in-place concrete exterior foundation walls on a continuous strip footing with interior concrete piers set on isolated concrete footings. The small basement space has a cast-in-place concrete floor slab where mechanical and electrical equipment are housed. The rest of the basement level is a crawl space with a natural sand floor. The first floor is a cast-in-place slab supported by the exterior foundation walls and interior concrete piers. The roof is framed with wood trusses, purlins and wood decking that is supported by the exterior CMU walls. The attic/first-floor ceiling is framed with wood members spanning between trusses. The structural systems are generally in good condition and still function as they were intended.

Figure 9: Typical concrete foundation and floor slab at basement area.

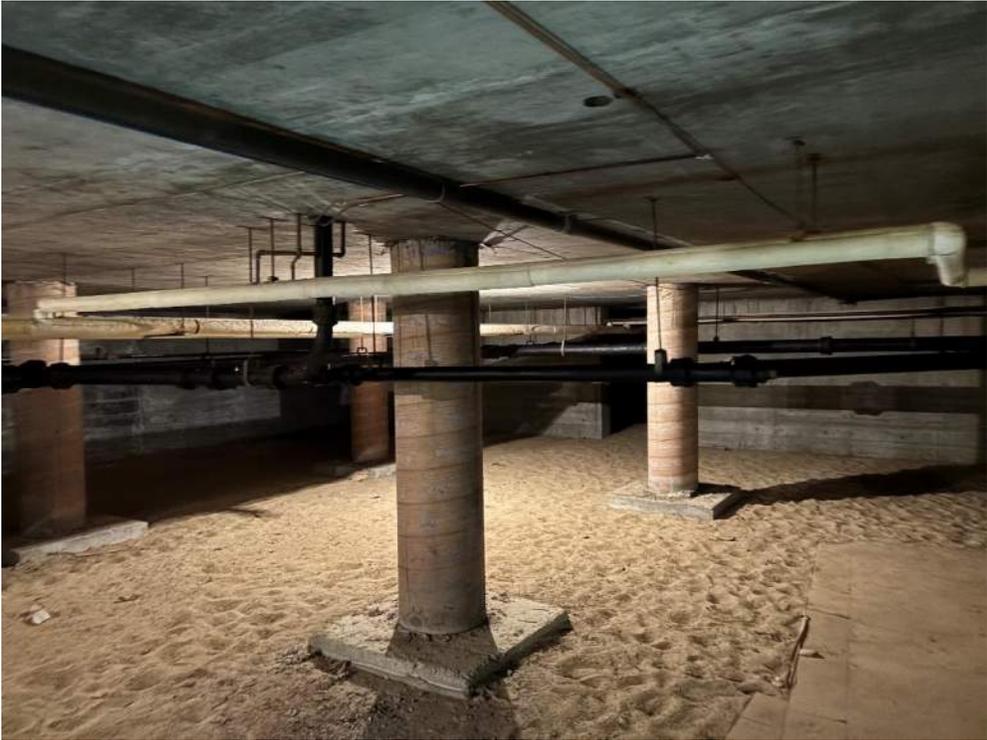
Figure 10: Interior concrete piers supporting first-floor slab.

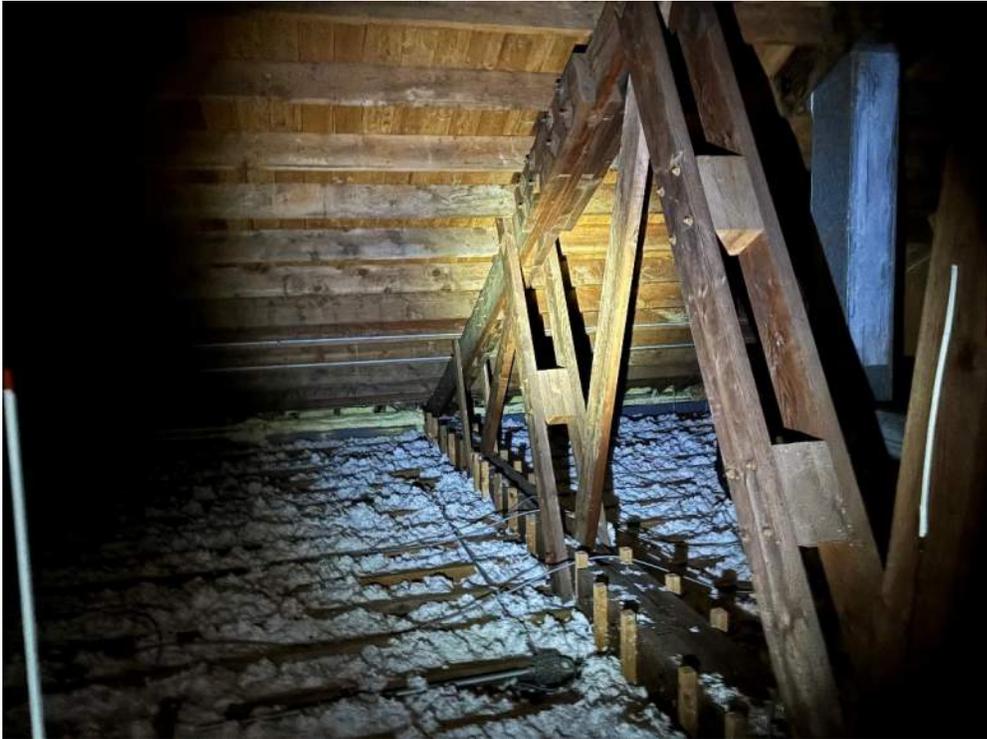
The gymnasium area is made up of wood glulam frames with wood purlins and wood roof panels along with CMU walls and brick façade. The area of the building is generally in good condition. The modular addition is conventionally wood framed with wood roof trusses on a cast-in-place concrete slab. This area of the building is in poor condition and well past its useful life.

Figure 11: Wood-framed roof trusses, purlins and roof decking.

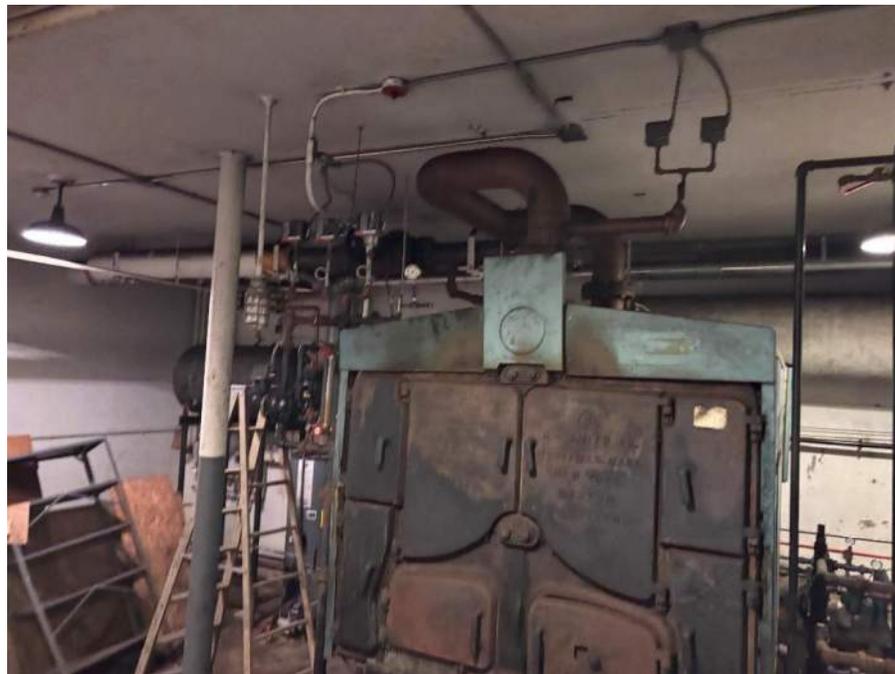
The facility was originally conditioned by an oil-fired, steam boiler system that is no longer operational. The 10,000-gallon exterior underground storage tank that served the boiler was demolished in 2023 and the existing facility has not been heated for the past several years. There is an abandoned dedicated septic tank and leach field system located at the rear of the building. It should also be noted that the building does not have a fire protection system, one would have to be installed complying with NFPA-13 regulations if this building were to be renovated under any development option.

Figure 22: Existing boiler, non-operational.

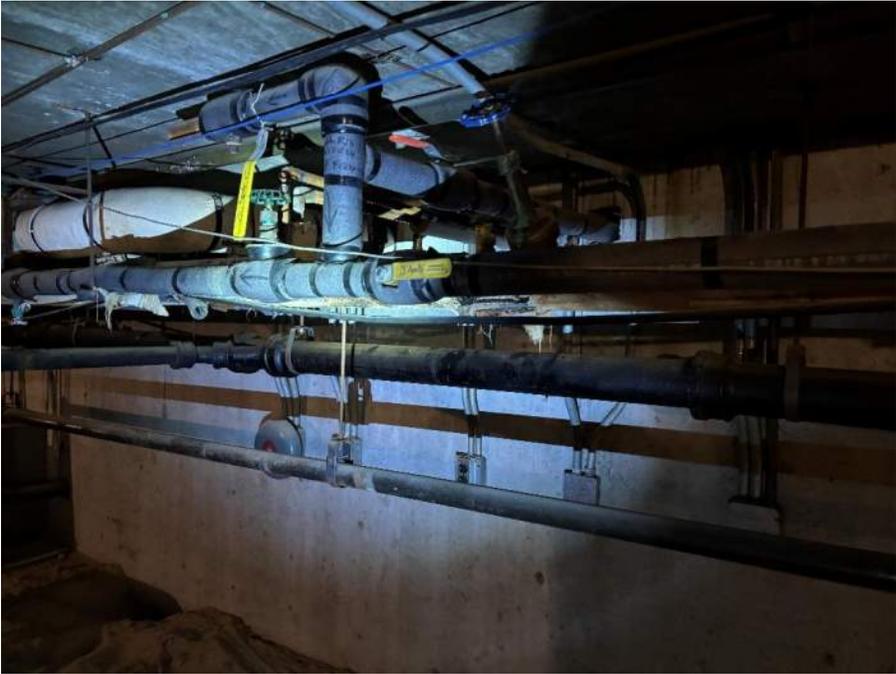
Figure 13: Mechanical and plumbing piping routed in crawlspace.

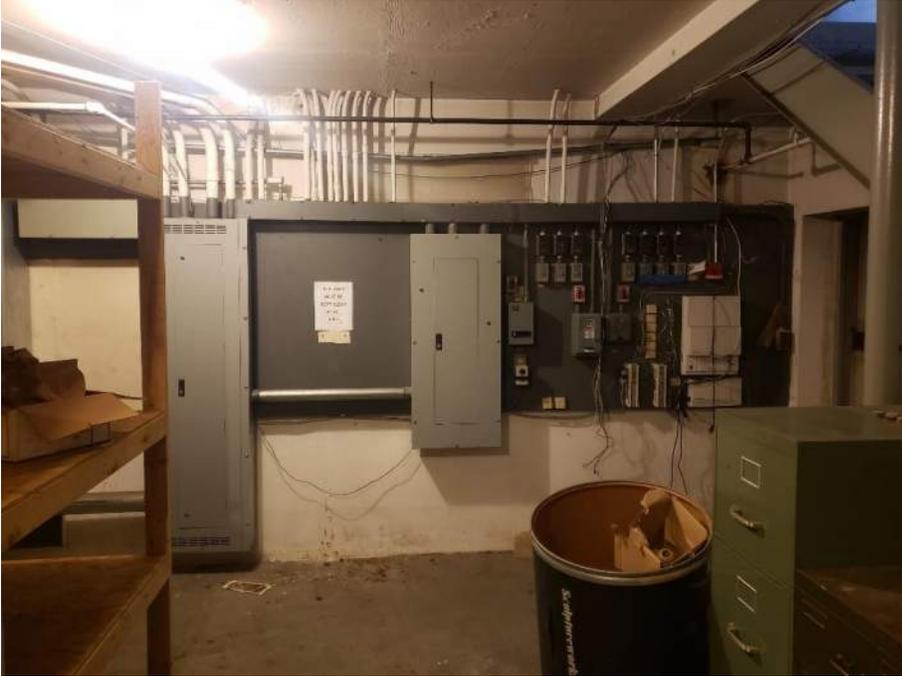
Figure 14: Existing electric service, undersized for development options.
