# COMPREHENSIVE FACILITIES ASSESSMENT

## COTUIT ELEMENTARY SCHOOL

140 Old Oyster Road, Cotuit, MA 02635

January 31, 2020  
H&A JN 1827.04

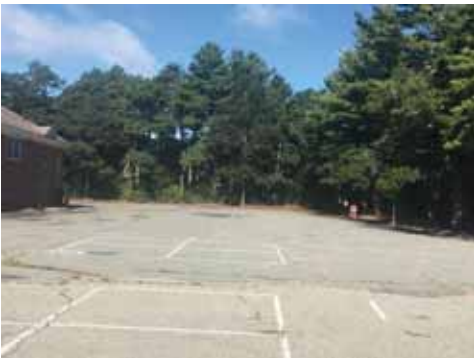
1.4: Bituminous pavement at rear of school in poor condition

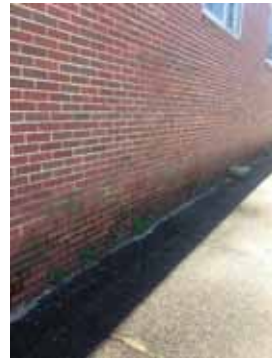
2.33: Algae growth at bottom of wall

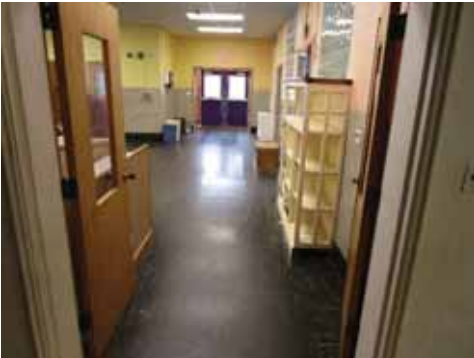
3.7: Asbestos floor tile in lobby area

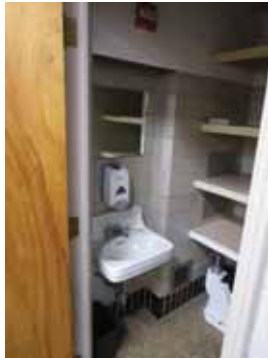
3.8: Remove fixtures in storage closet

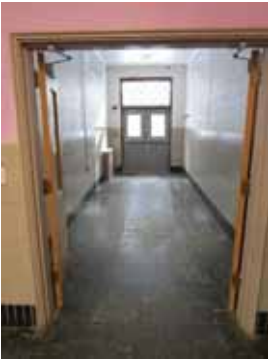
3.35: Double 30" doors do not comply to egress requirements

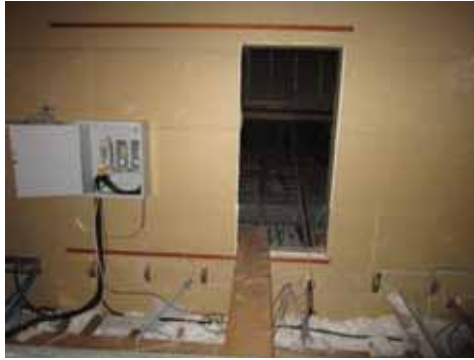
3.36: An opening has been cut in the attic firewall

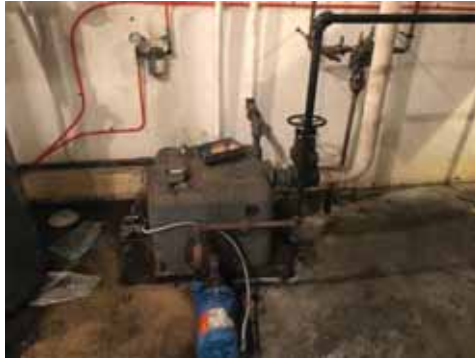
4.2: Existing condensate receiver and pump

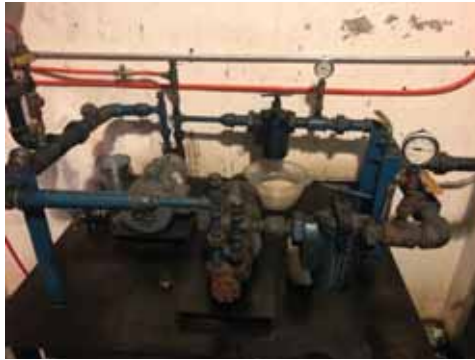
4.5: Boiler fuel oil pumps

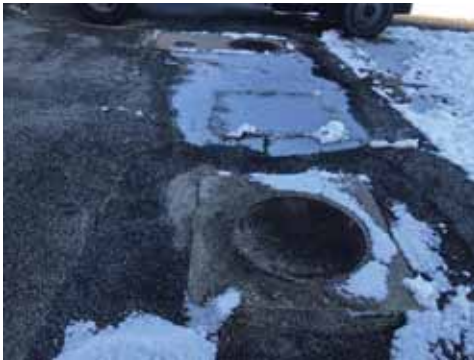
4.7: Parking Lot – Fuel oil tank access covers

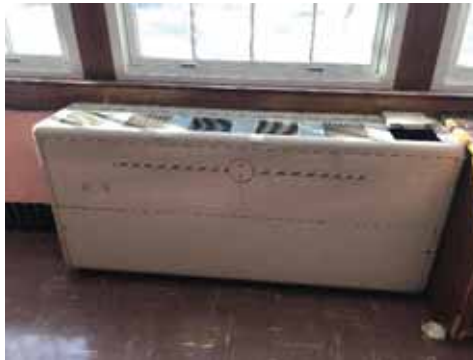
4.8: Classroom unit ventilator

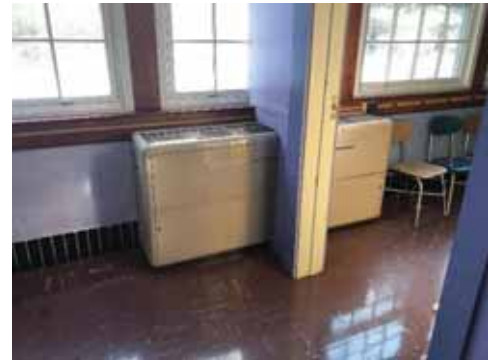
4.9: Classroom unit ventilator installed between two classrooms

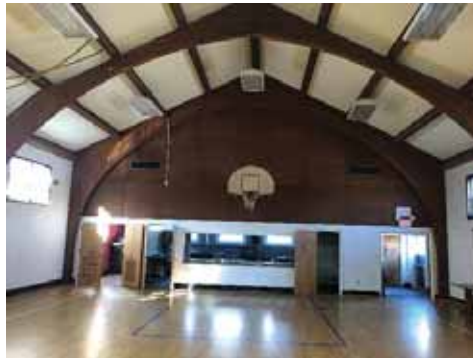
4.11: Cafetorium sidewall supply diffusers

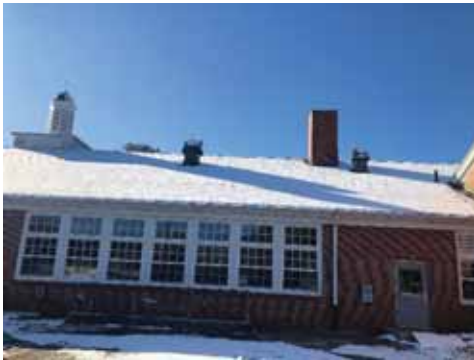
4.13: Roof exhaust ventilators

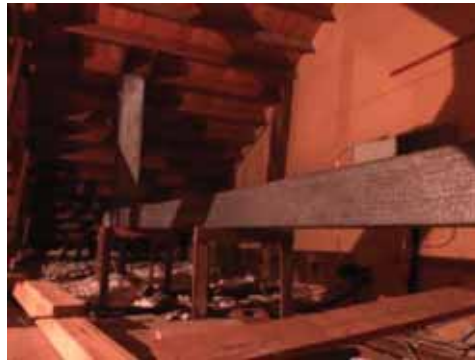
4.14: Attic – Exhaust ductwork

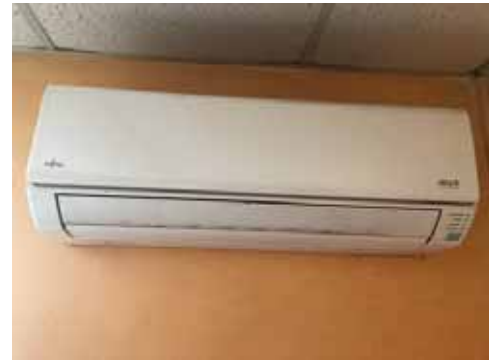
4.15: Modular classroom – ductless AC unit

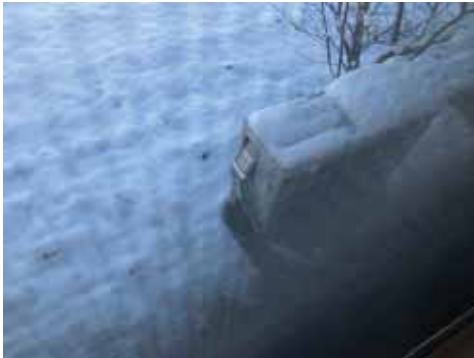
4.16: Modular classroom – outdoor condenser unit

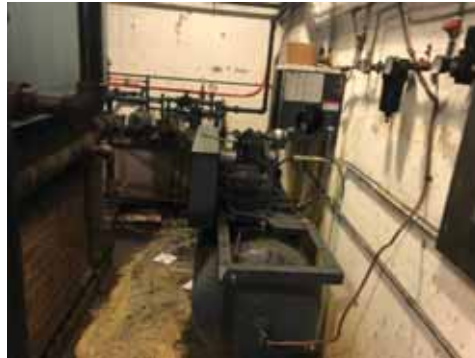
4.17: Pneumatic ATC compressor

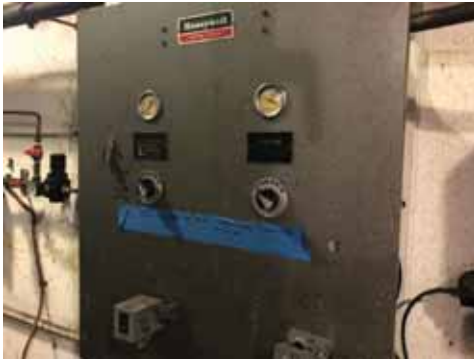
4.19: Pneumatic control panel

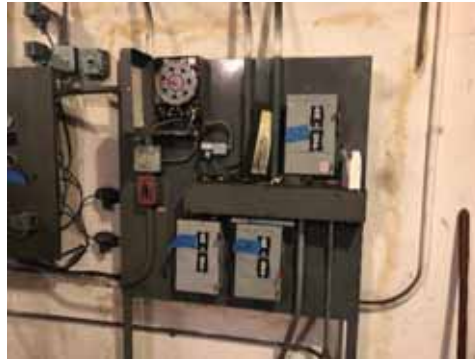
4.20: Pneumatic control panel

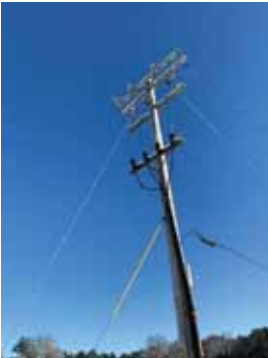
5.1: Main building riser pole

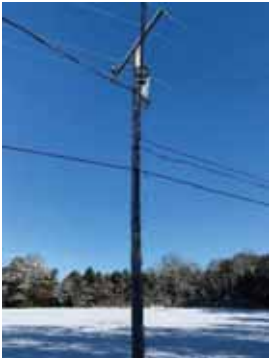
5.2: Modular building riser pole

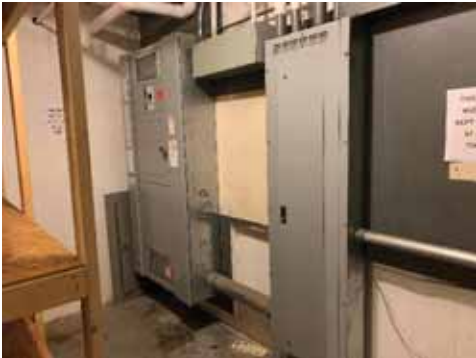
5.5: Main circuit breaker switchboard

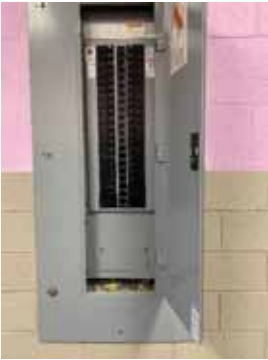
5.7: Typical panel in corridor

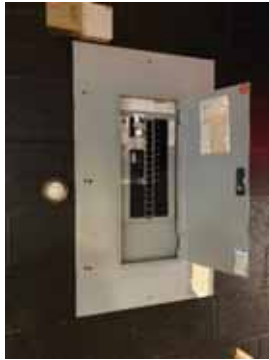
5.8: Typical panel in gym area

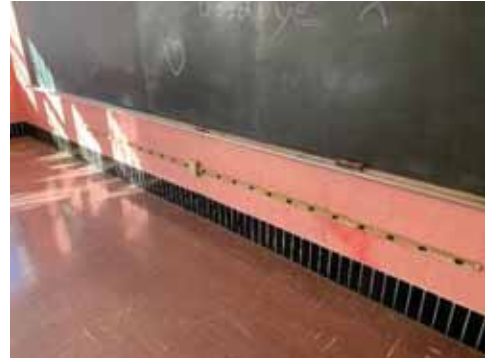
5.9: Outlets installed using surface raceway

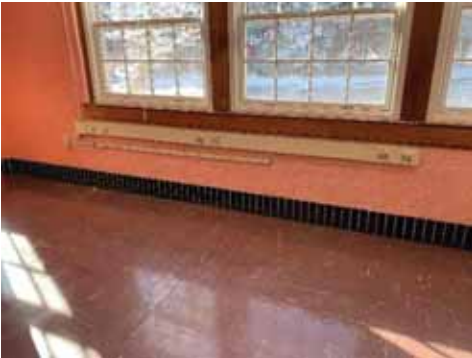
5.10: Outlets installed using surface raceway

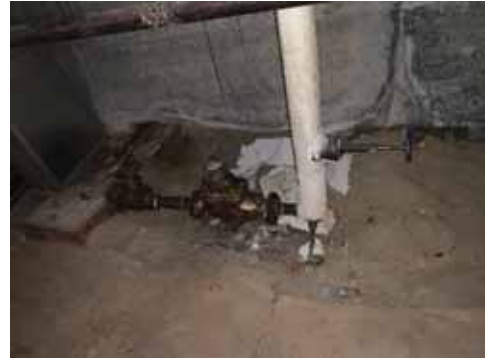
6.9: Domestic water service & meter

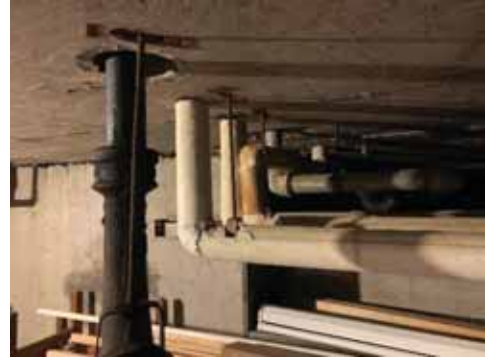
6.12: Water piping in crawl space

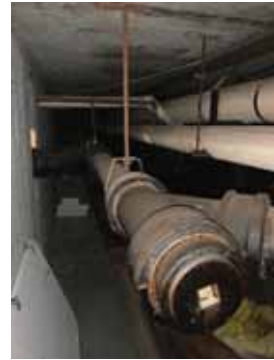
6.15: Cast iron piping in crawl space

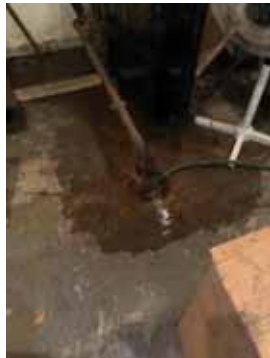
6.17: Boiler Room drain clogged

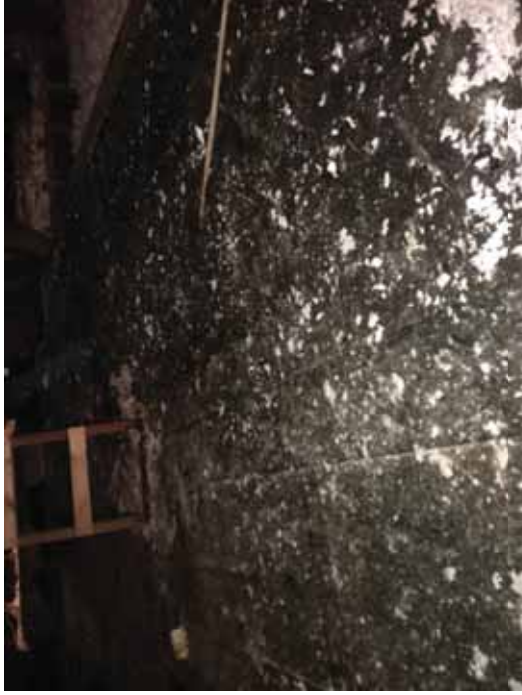
Figure 1: Tar paper on wood floor of attic under cupola

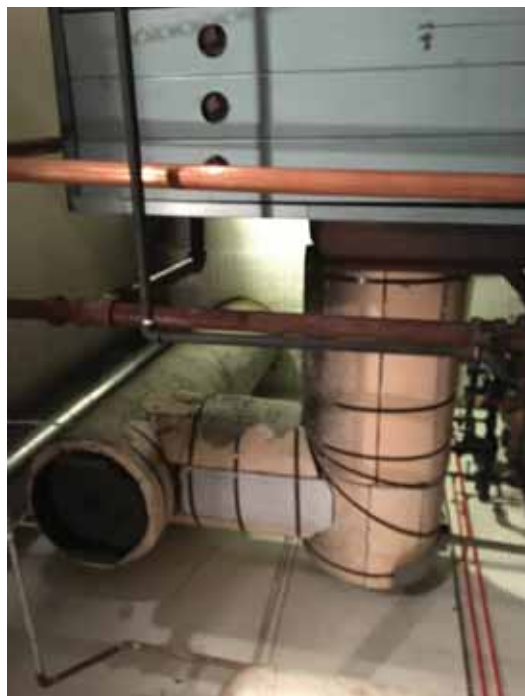
Figure 3: Pink boiler breeching insulation. Note assumed grey boiler breeching insulation at top

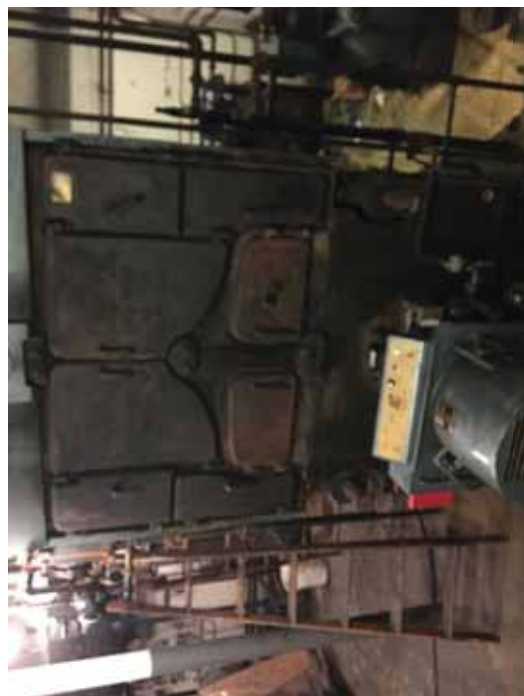
Figure 4: Boiler unit (in operation, assumed ACM components inside)

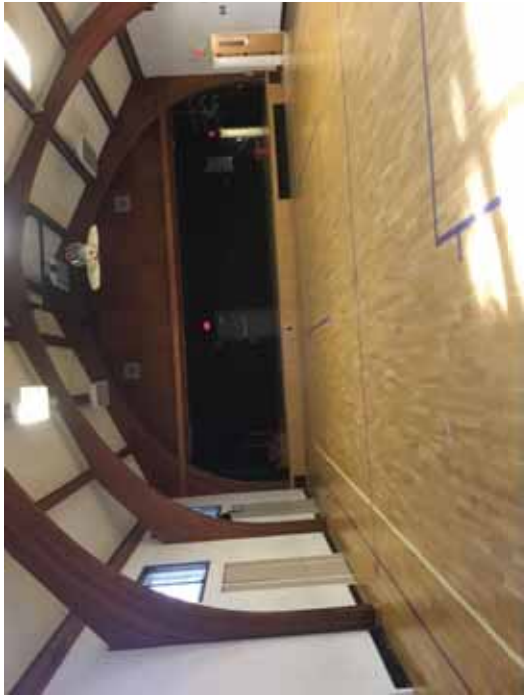
Figure 21: Multi-purpose room. Note no paper under floor.

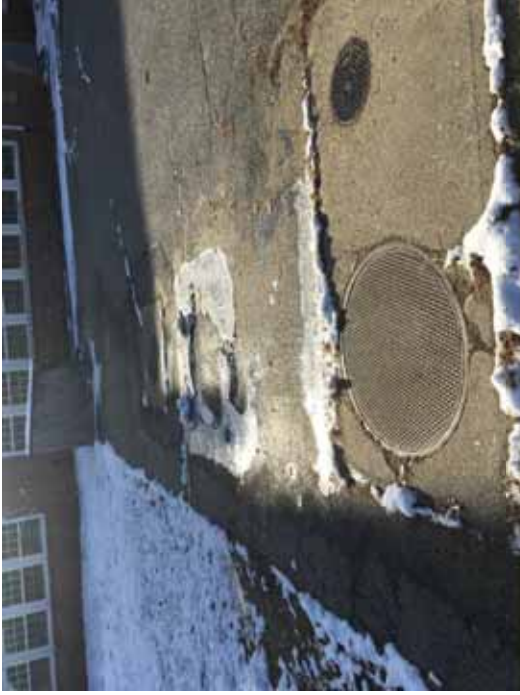
Figure 23: UST location behind building

It is recommended that identified Other Hazardous Materials be properly removed, disposed or sent to a recycling facility a qualified contractor. If proposed renovation activities will impact the observed AST and USTs, the tanks should be properly drained and handled by a qualified contractor.

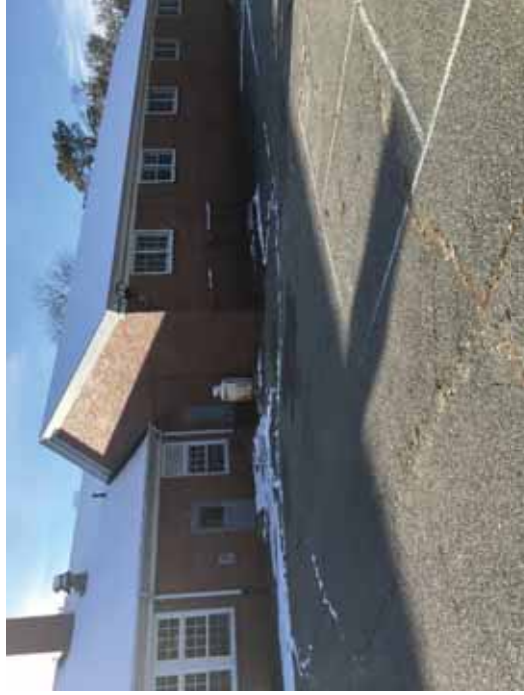
Figure 24: Propane tank at the rear of the building

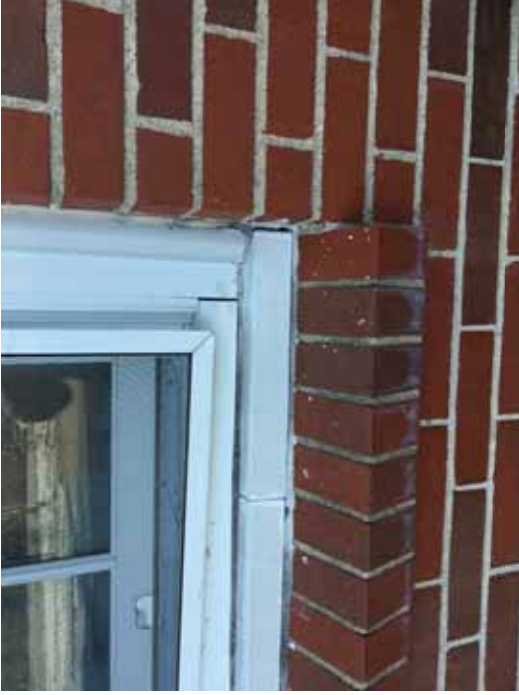
Figure 25: Exterior window caulk
