# COMPREHENSIVE FACILITIES ASSESSMENT

## COTUIT ELEMENTARY SCHOOL

140 Old Oyster Road, Cotuit, MA 02635

January 31, 2020  
H&A JN 1827.04

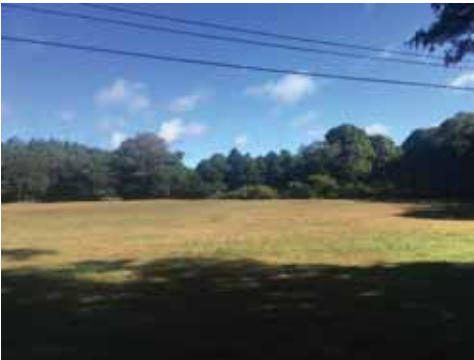
1.1: Open play area behind school

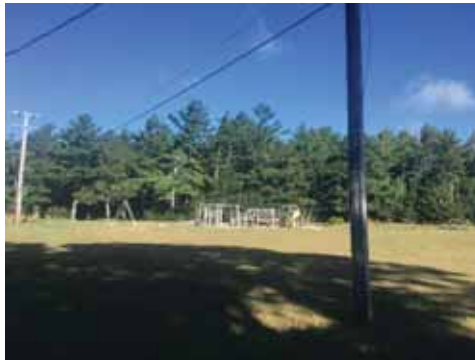
1.2: Playground behind school

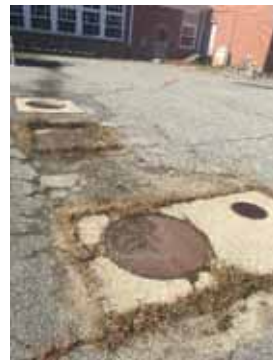
1.3: Underground fuel storage tank

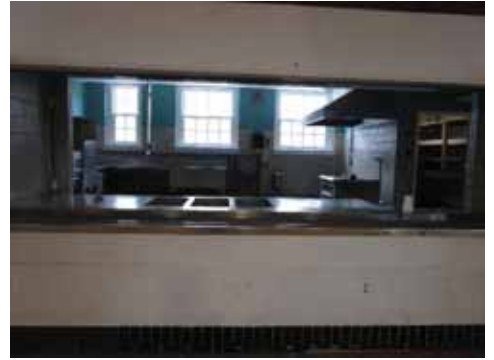
3.5: Small kitchen area with limited equipment

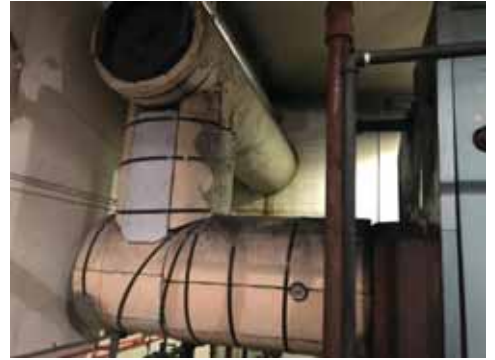
4.3: Boiler breeching

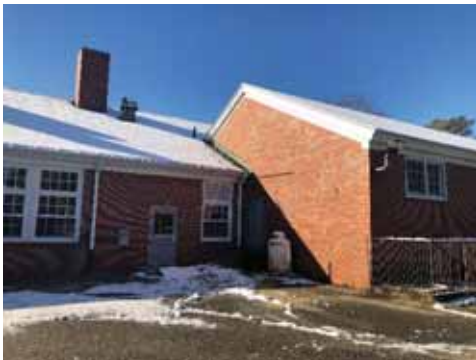
4.4: Boiler chimney

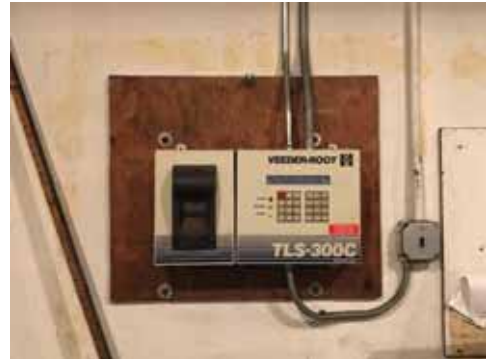
4.6: Fuel oil monitor

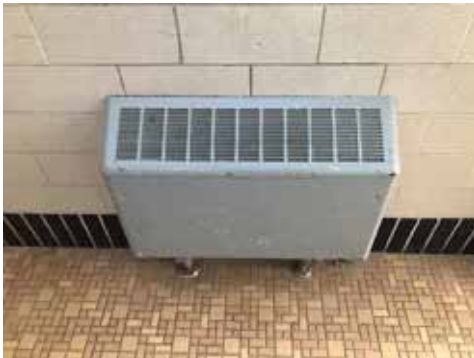
4.10: Steam convector

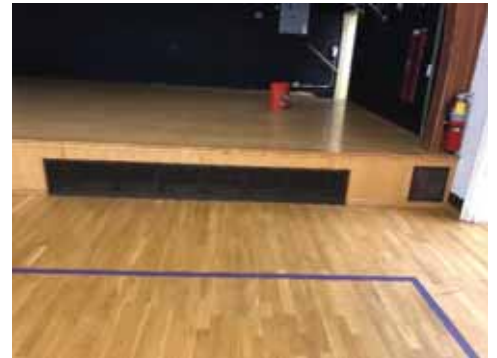
4.12: Cafetorium low return registers

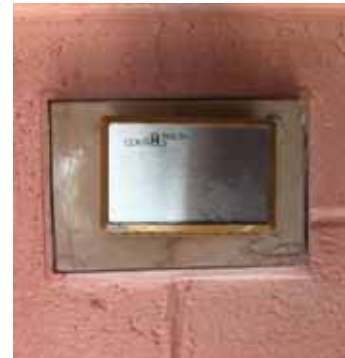
4.18: Typical thermostat

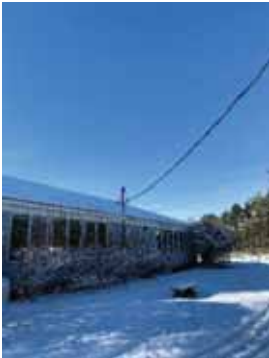
5.3: Modular CR service

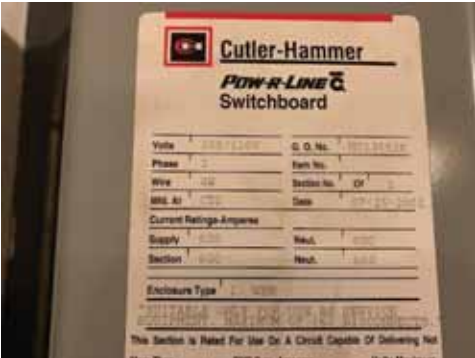
5.4: Main switchboard

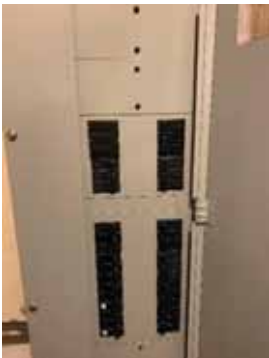
5.6: Distribution panel

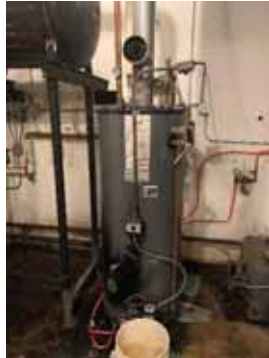
6.11: Domestic water heater

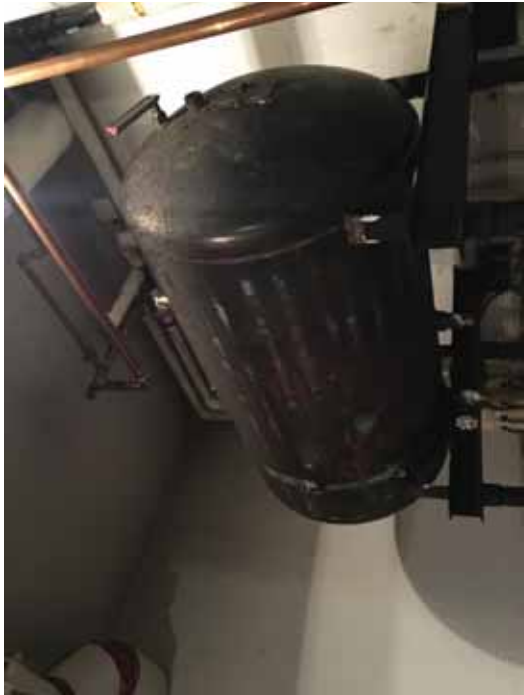
Figure 5: Storage tank in Basement Boiler Room

It is recommended that identified Other Hazardous Materials be properly removed, disposed or sent to a recycling facility a qualified contractor. If proposed renovation activities will impact the observed AST and USTs, the tanks should be properly drained and handled by a qualified contractor.

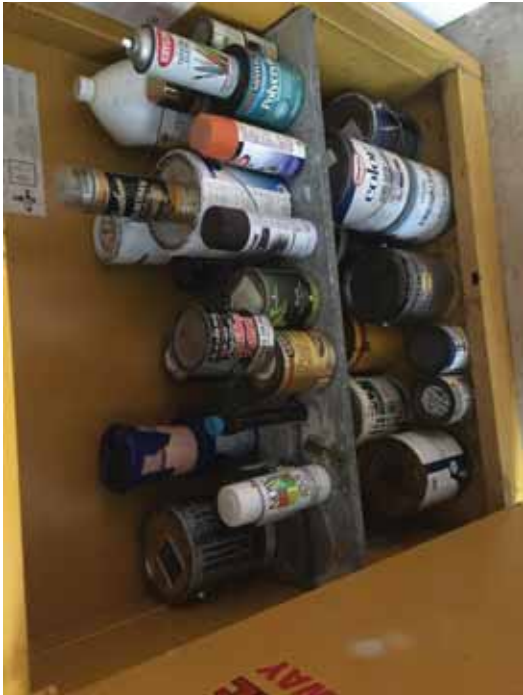
Figure 6: Inside flammable storage cabinet in Classroom 1

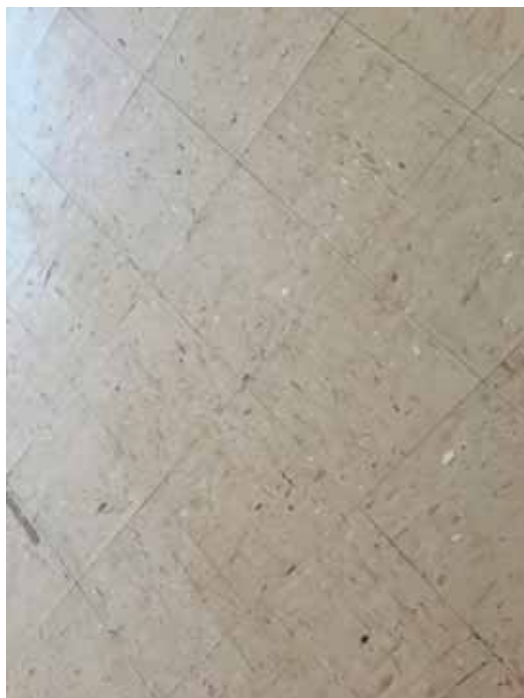
Figure 7: 12" x 12" Cream streak floor tile

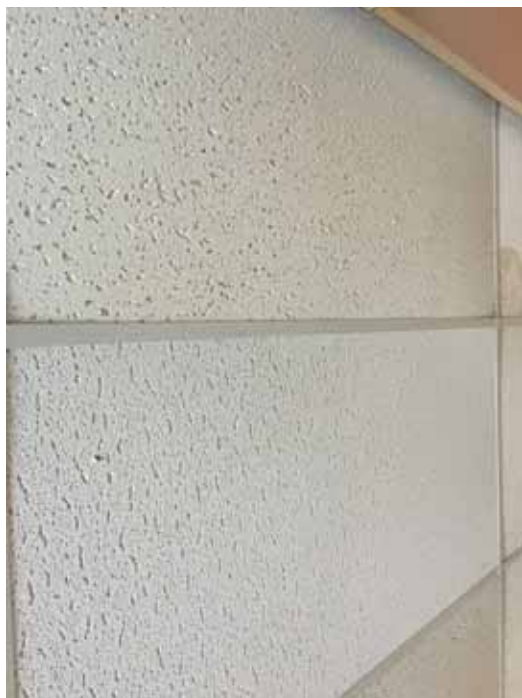
Figure 8: 2' x 4' Crow feet ceiling tile (Left), 2' x 4' Rough finish white ceiling tile (Right)

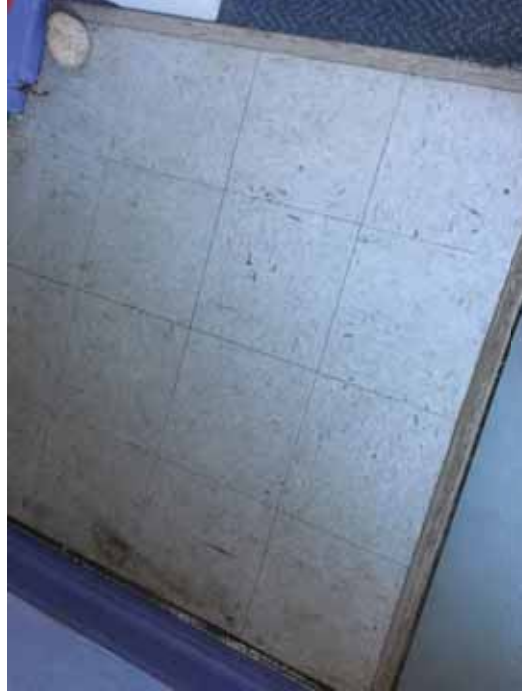
Figure 10: 12" x 12" White with blue streak floor tile

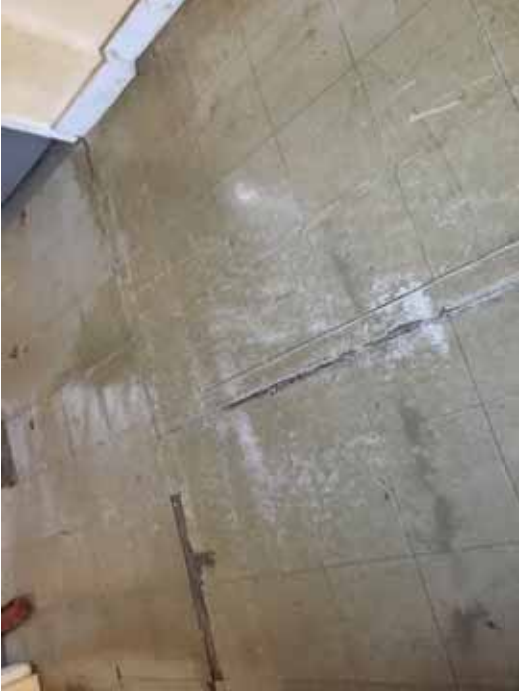
Figure 11: 12" x 12" Beige floor tile

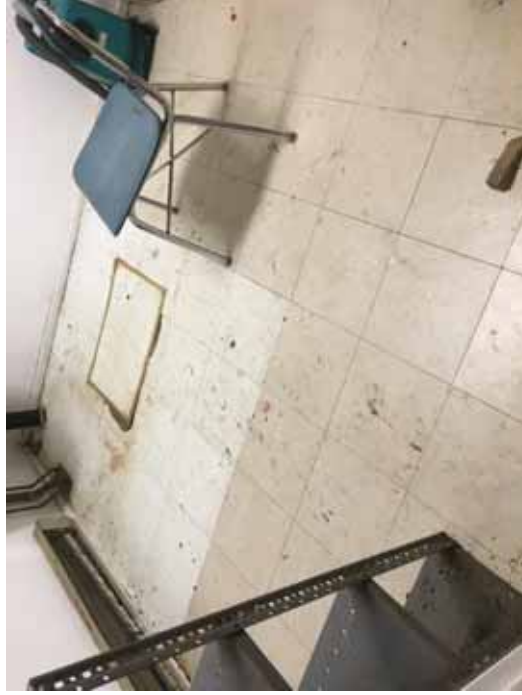
Figure 12: 12" x 12" White with multicolor fleck floor tile

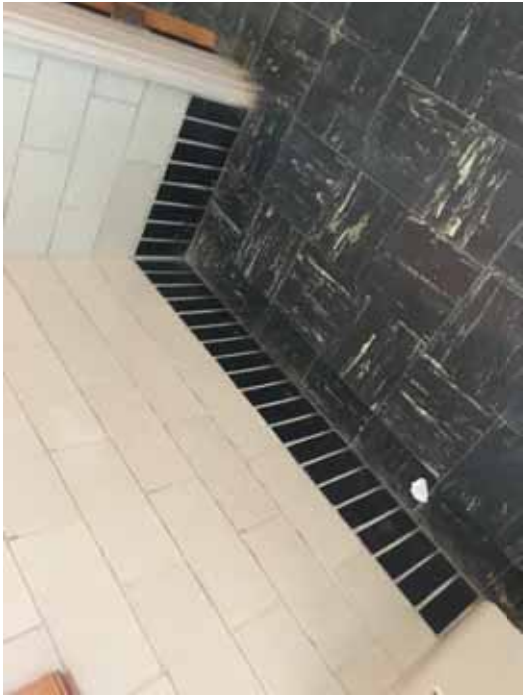
Figure 14: Ceramic baseboard tile grout, concrete block wall grout

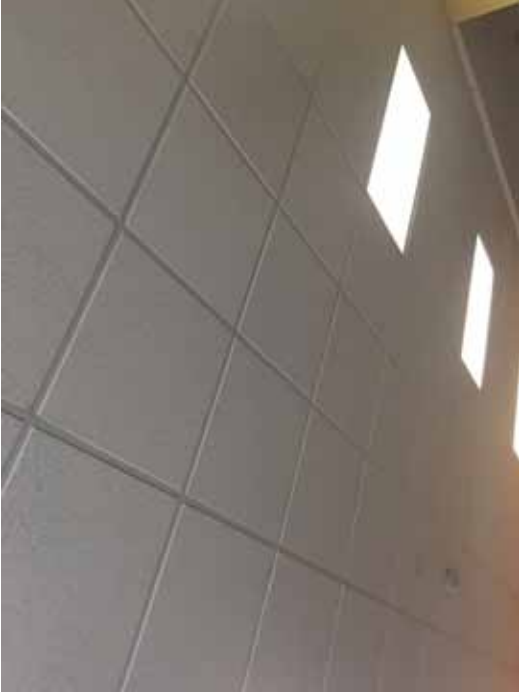
Figure 19: 2' x 2' Crow feet ceiling tile

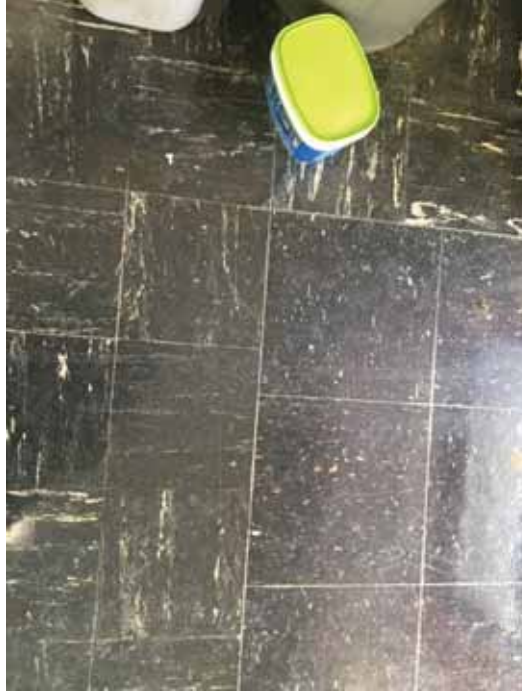
Figure 20: 12" x 12" Black streak floor tile (bottom left). Remaining floor tile is ACM 9"x9" Black streak floor tile.

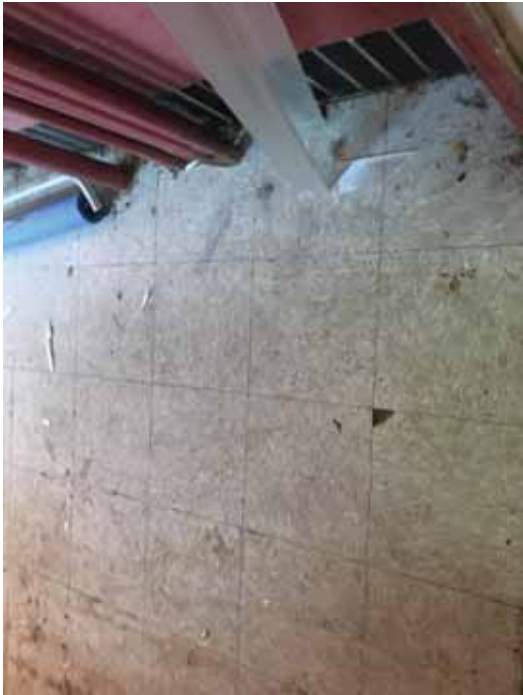
Figure 22: 12" x 12" Grey mottled floor tile (underlain by ACM mastic)
